1989 Ford Truck F 250 4WD Pickup V8-445 7.3L DSL

M/T - Clutch Fluid Leaks/Incomplete Release

Article No. 90-16-7

^ CRACKS - DASH (ENGINE COMPARTMENT BULKHEAD) - [CLUTCH MASTER CYLINDER AREA](#) - VEHICLES BUILT BEFORE 6/15/90

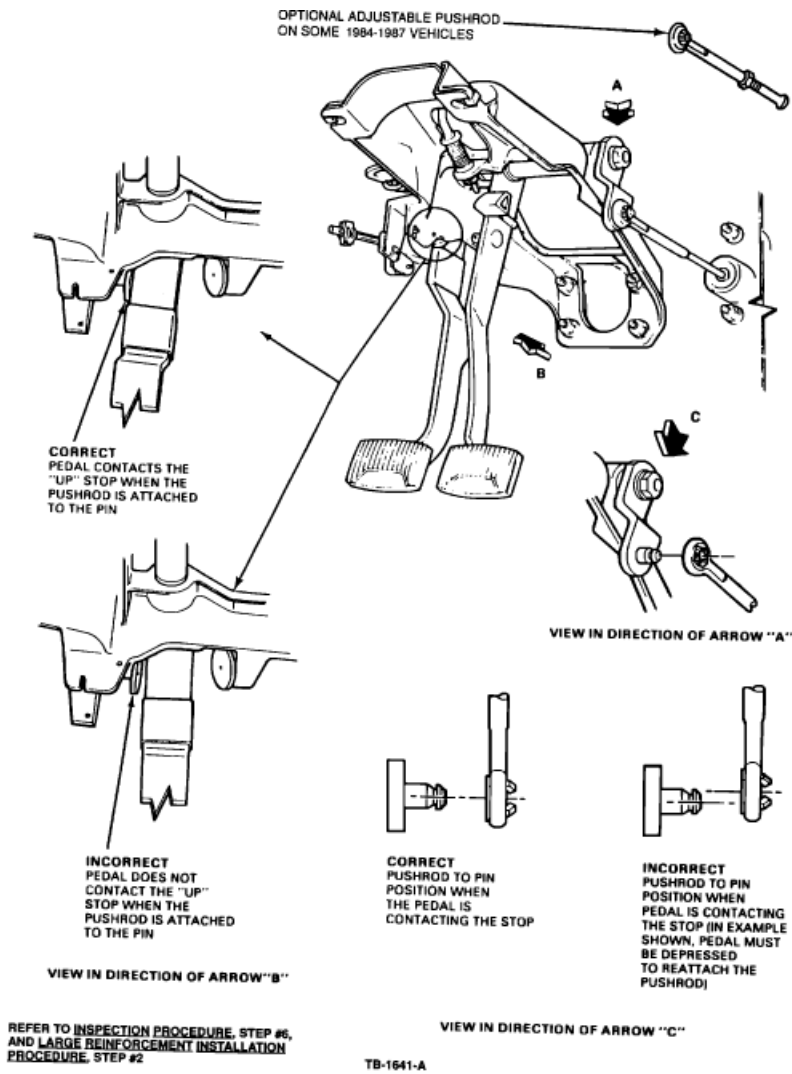
Figure 1

- b. Make sure the hole in the pushrod lines up with the pin, for those units requiring a minimal force for installation, Figure 1.
 - c. If it does not line up correctly, install an adjustable pushrod (except 1988 and later models) or replace the clutch release lever (required on 1988 and later models), cutting a new seat on the cross shaft splines.
7. Test drive the truck again, checking for improved [clutch](#) release.

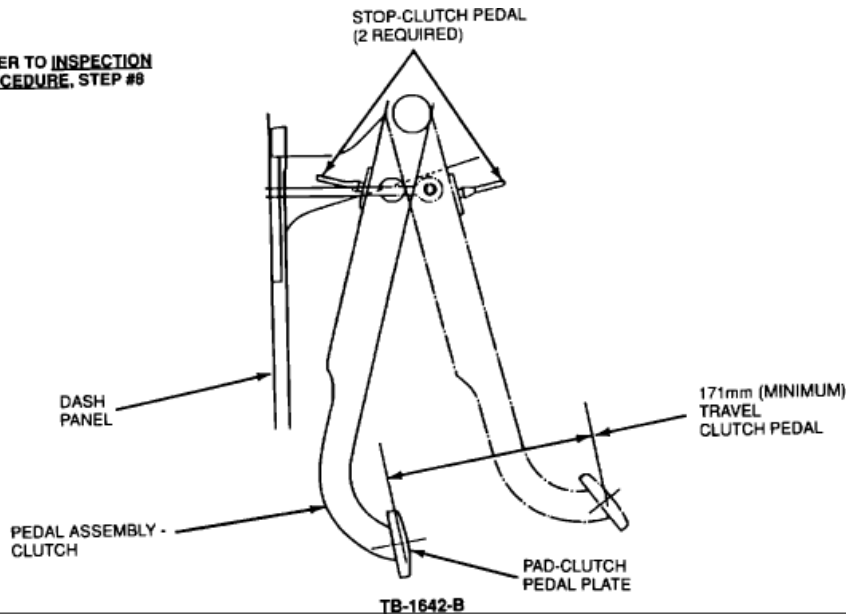
Figure 2

8. If there is no improvement, inspect the truck for adequate release bearing travel.
 - ^ It should be 11 mm or greater for full pedal travel.
 - ^ Pedal travel at the center of the pedal pad should be 6.75" (171 mm minimum) or more, Figure 2.

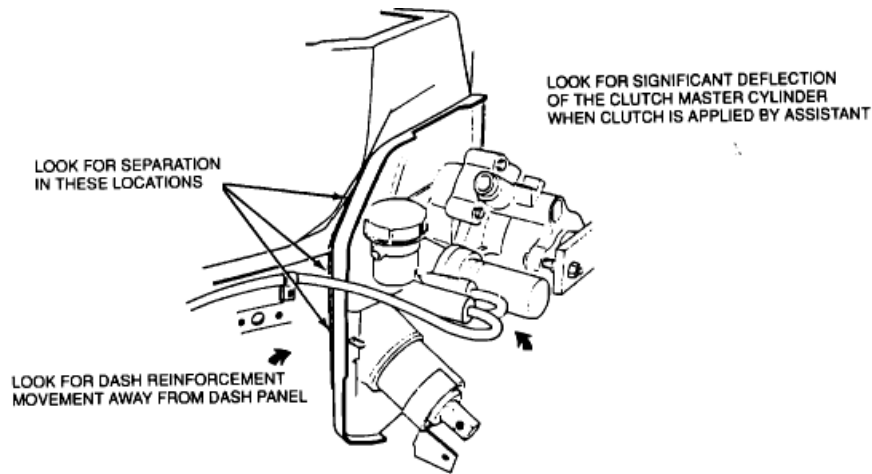
Figure 3

- c. Look for the dash reinforcement moving away from the dash, Figure 3.
 - d. On 1987 and earlier models, look down inside the cowl cover at the cowl where it is attached to the dash reinforcement. Check for pulled spot welds.
11. If there is significant movement of the dash or [clutch master cylinder](#), proceed as follows:
- a. Remove the steering column and its dash toe plate and seal. Refer to the appropriate Light Truck Shop Manual, Section 13-07 for service details.
 - b. Inspect the dash inside the cab and look for:
 - ^ Pulled spotwelds and cracked or torn sheet metal.
 - ^ Cracks in the brake and clutch pedal support

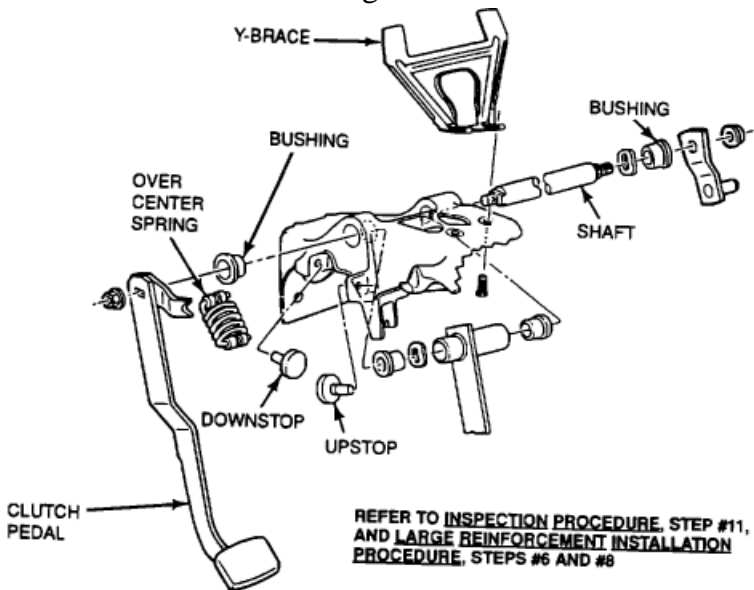
Figure 4

^ Missing Y-brace fasteners and a broken or detached Y-brace, Figure 4.

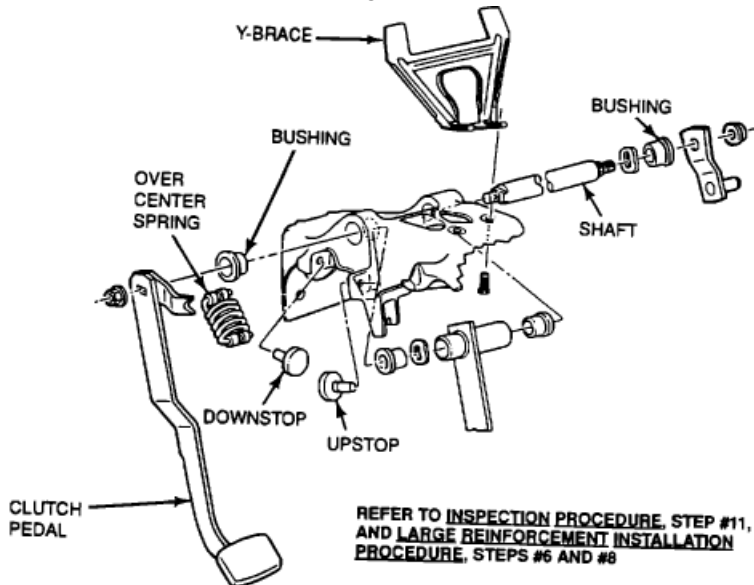
Figure 4

8. Thoroughly inspect the brake and [clutch](#) support again for cracks in the casting and worn bushings. Also, inspect the "Y" brace for cracks and missing fasteners. Replace as necessary, Figure 4.
9. Remove excess body sealer in the area of the [clutch master cylinder](#), inside the dash.
10. Carefully remove the cowl top cover 12 fasteners (7 in front, 5 in rear).
