1989 Ford Truck F 250 4WD Pickup V8-445 7.3L DSL

M/T - Clutch Fluid Leaks/Incomplete Release

Article No. 90-16-7

^ CRACKS - DASH (ENGINE COMPARTMENT BULKHEAD) - [CLUTCH MASTER CYLINDER AREA](#) - VEHICLES BUILT BEFORE 6/15/90

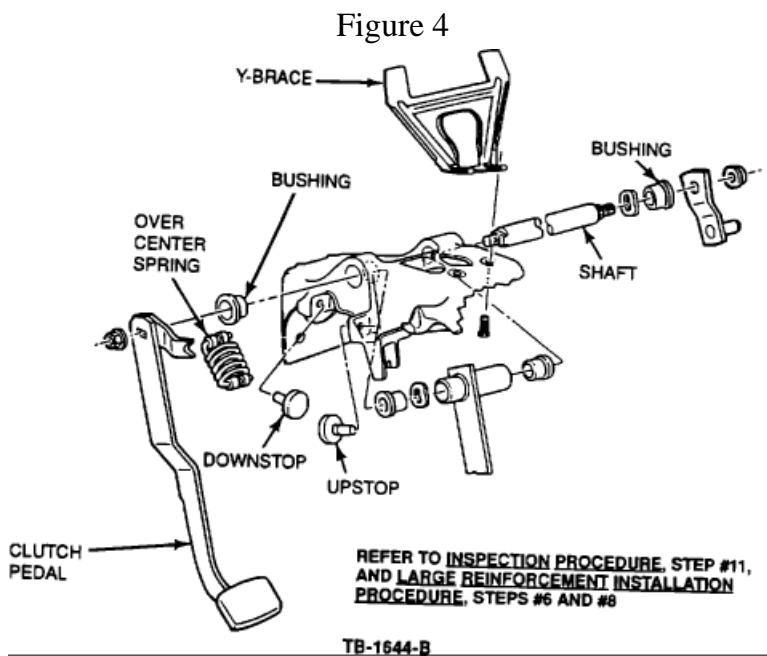
- c. Loosen the two (2) fasteners attaching the brake and clutch pedal support to the Y-brace, Figure 4.
7. Check for cracks.
 - a. Pull back the floor covering and dash sound insulator. (it may be helpful to remove the accelerator pedal.)
 - b. Inspect the area for pulled welds and torn dash sheet metal.
